Project Boats UK

Is your Drascombe centreplate starting to show ageing or corrosion?

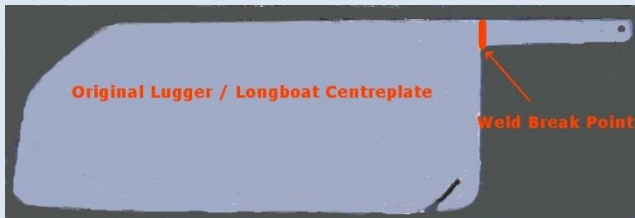
My Lugger is a 1987 Mk2 and due the centreplate arm breaking off we have found that some (if not all) older centreplates had the arm welded on before galvanising . As the galvanising is penetrated by water the weld rusts causing it to give way, at which time the arm breaks off, the plate rotates off the retaining pin and it sinks at the speed of light!

What is the answer?: we are now able to offer centreplates cut as one piece from 304 or 316 stainless steel. Each plate is precision cut by laser to your specification and the leading edge is radiused for streamlining .
